ARBORIST REPORT

North 40 Property, Los Gatos, California

OCTOBER 14, 2013

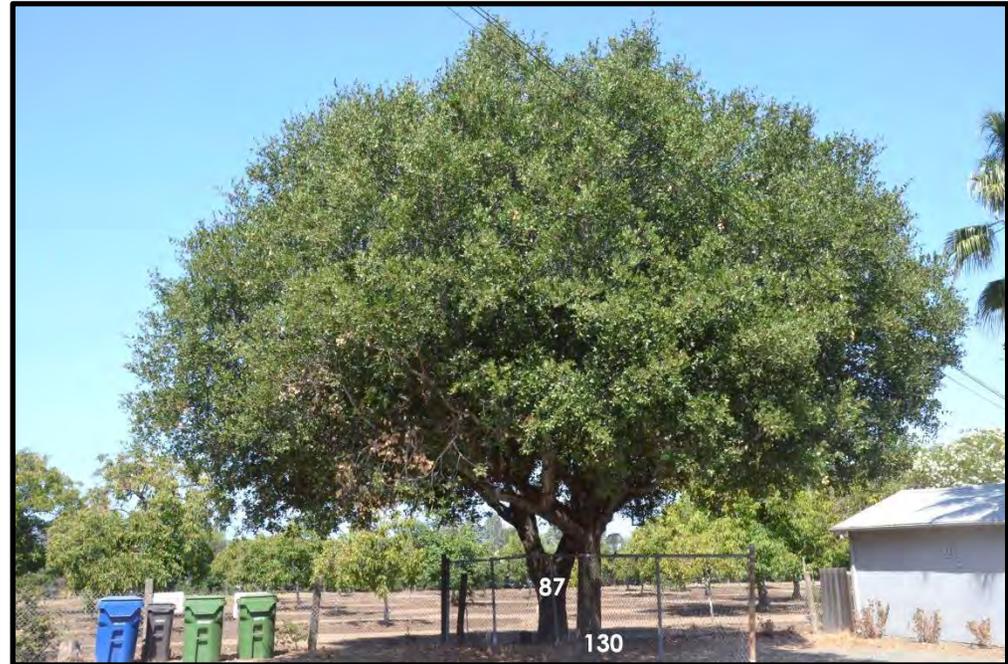
Cover photo: **coast live oak #130**, with **#87** in the background. These trees have Good/Excellent and Good preservation suitability, respectively. They are located near the corner of Los Gatos Boulevard and Lark Avenue. All photos in this report were taken by D. Ellis on September 12, 2013.

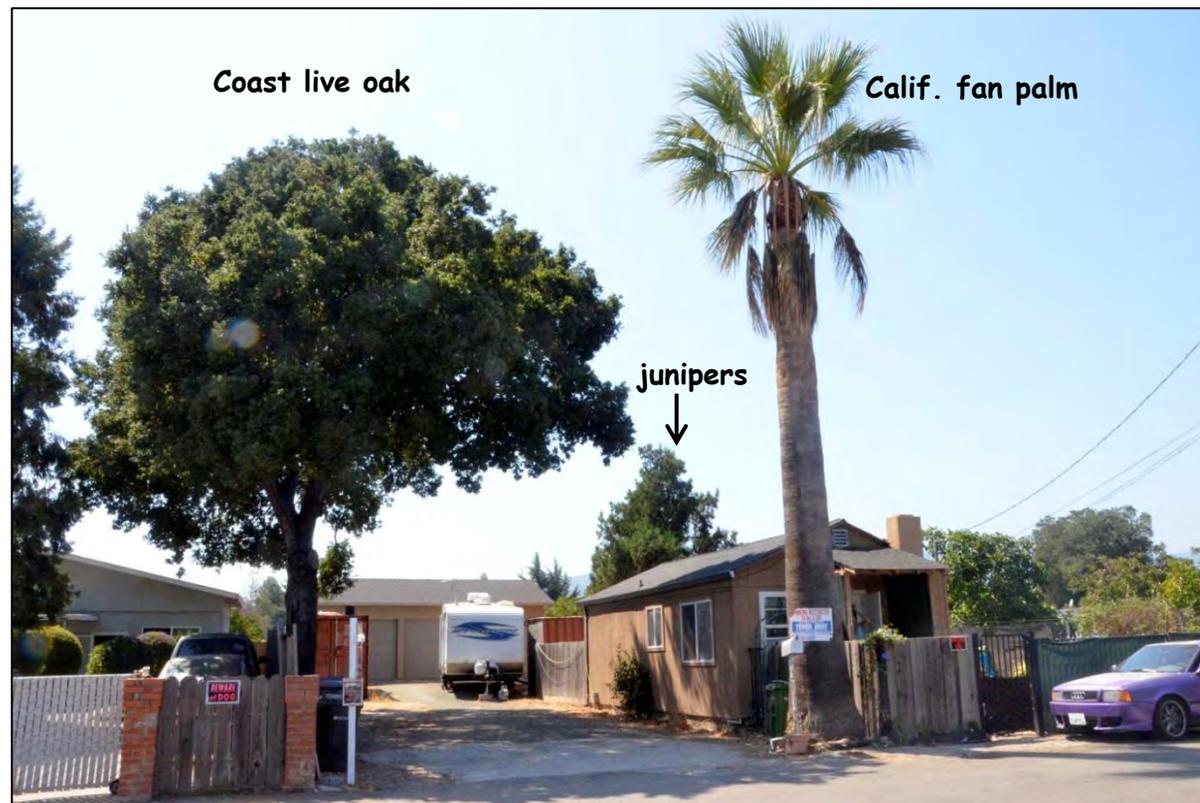
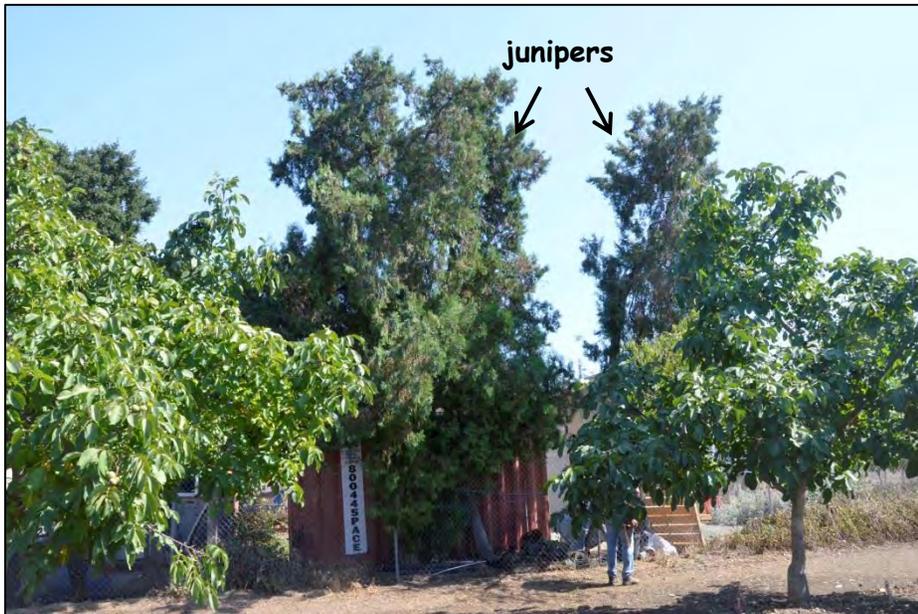
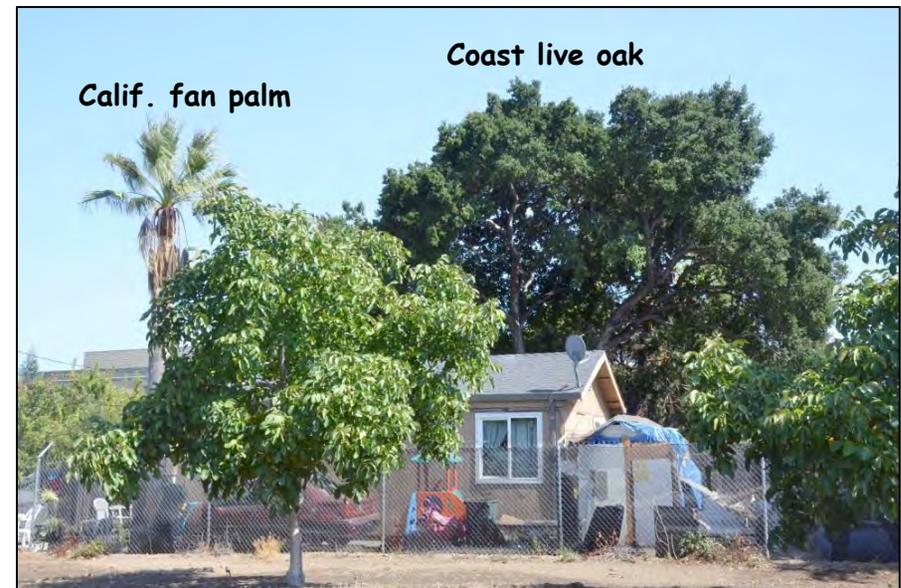
Fales property trees viewed from the orchard to the southwest

We were instructed by the developer not enter the Fales property in order to evaluate the trees there, but instead to view any trees from outside the property. The photos below and on the next page show the trees on this property, viewed from the street and orchard. These four trees are not included in any of the previous tree tables. One **coast live oak**, one **California fan palm** and two large **junipers** inhabit the property. The oak seems to have Fair/Good preservation suitability, the California fan palm is "Good" and the junipers are "Fair/Poor". I should verify the condition of these trees with a closer inspection from the Fales property, however.

Upper photo: the two **juniper trees**. Foreground trees in the orchard are walnuts.

Lower photo: the **coast live oak** and **California fan palm**. Foreground tree is also an orchard walnut.

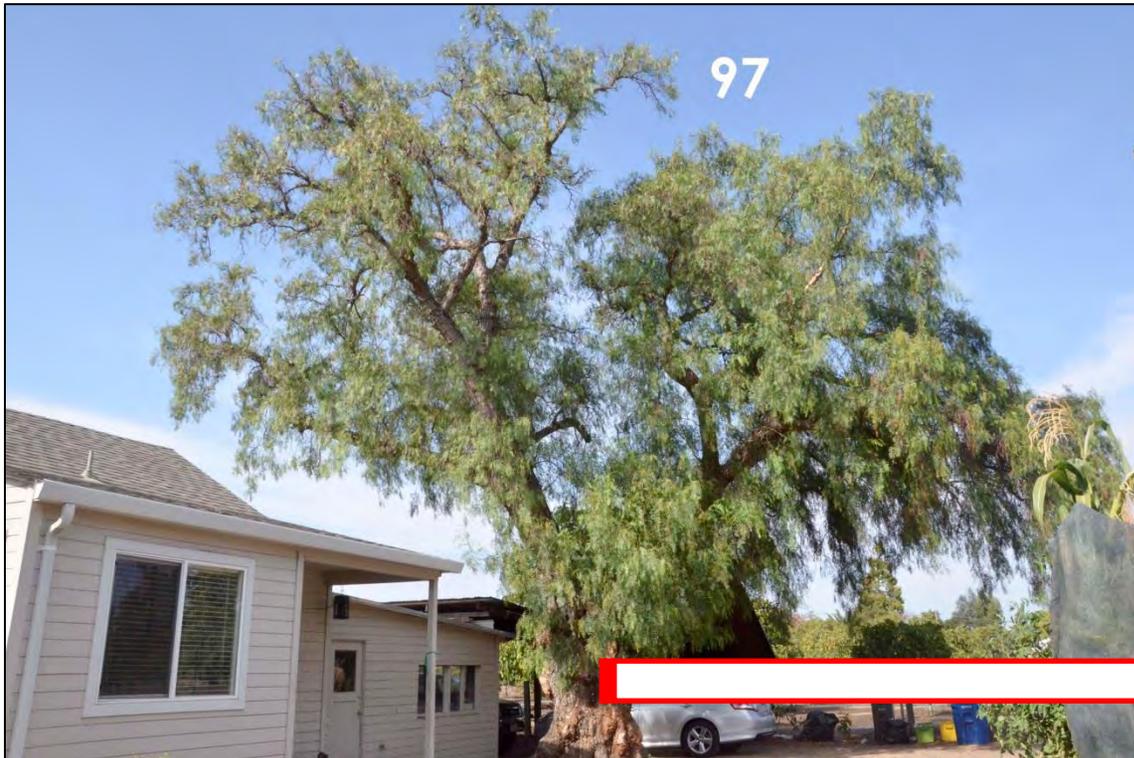
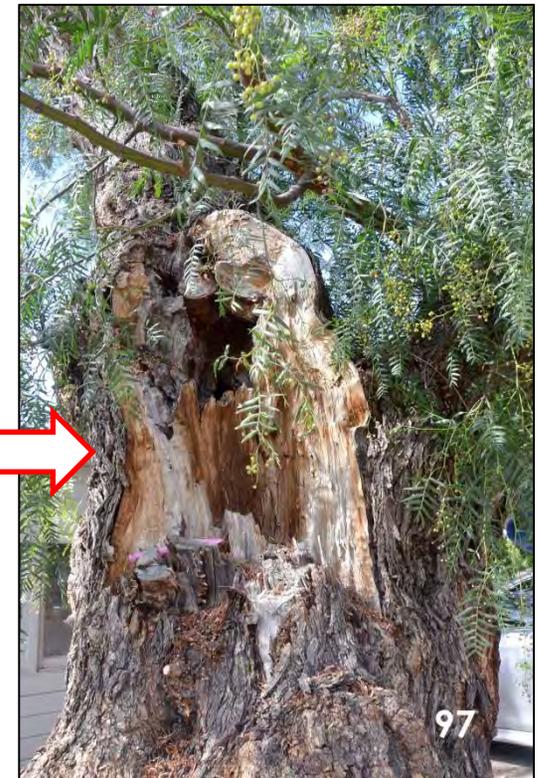
California pepper tree #97 should be removed ASAP. This tree is infected with a wood decay fungus and the fungal fruiting bodies are popping out all over the trunk. I recommended that this tree be removed in my 2011 report because it posed high risk to the residents of the house. Since then it has dropped a very large branch (at least 18 inches in diameter). Looking into the wound caused by this branch failure I can see that the trunk of the tree is hollow.

1. **Remove California pepper tree #97 ASAP.** It poses high risk to occupants and visitors of the adjacent house.
2. **Remove all trees listed as having “Unacceptable” or “Poor” preservation suitability.** In most instances, trees with “Fair/Poor” preservation suitability should be removed as well. These trees are listed in Table 5 on page 8.

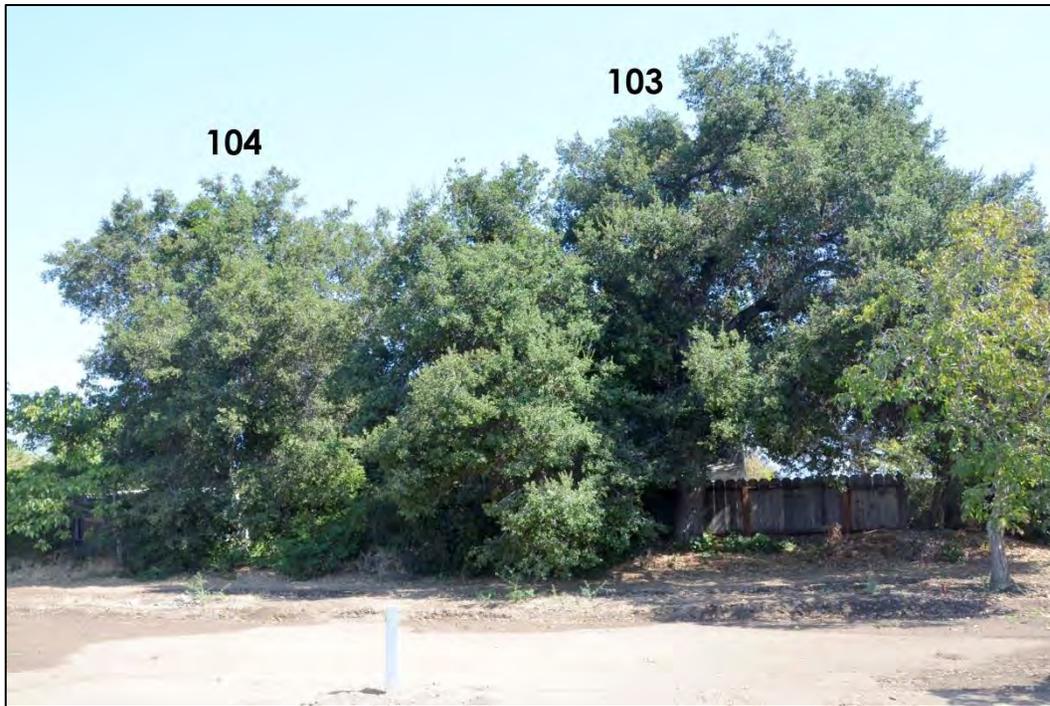
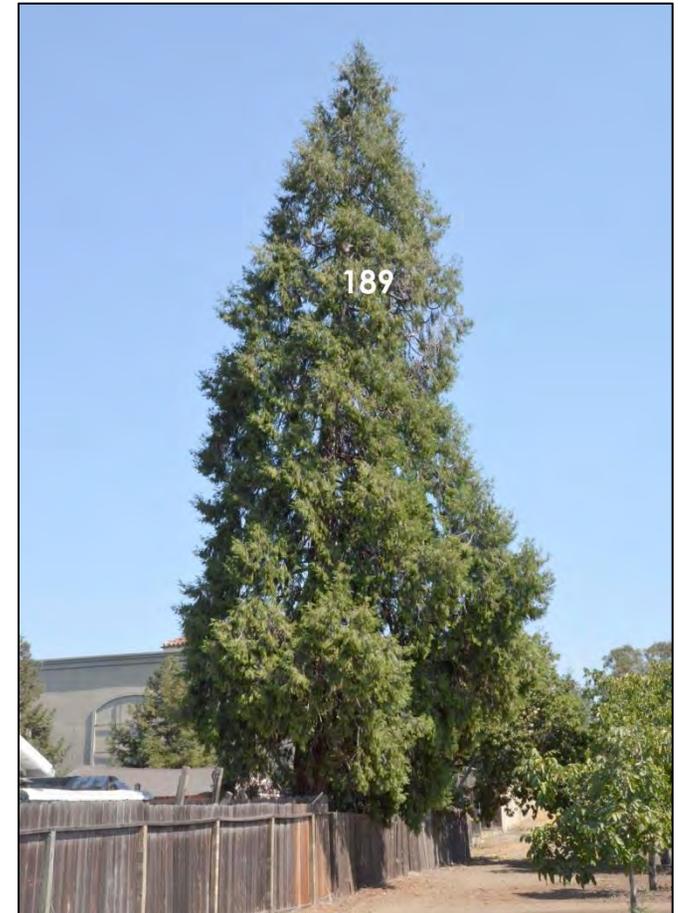
Upper photo: **coast live oaks #103 and 104**, large trees with 19 and 33 inch trunk diameters. Both trees have "Good" preservation suitability.

Lower photo: **incense cedar #189**, another large tree with a trunk diameter of 31 inches. This tree also has "Good" preservation suitability.
