MEMORANDUM

Date: January 27, 2017 Project Number:
To: Brian Lee P.E. Project Manager - City of Half Moon Bay
From: Jason Drew CPECS - Project Manager and Ryan Shafer P.E. - Principal
Subject: Seymour Ditch – Preliminary Field Observations

Field Map of Observed Stormwater Sources
SEYMOUR DITCH EROSION CONTROL
HALF MOON BAY, CA

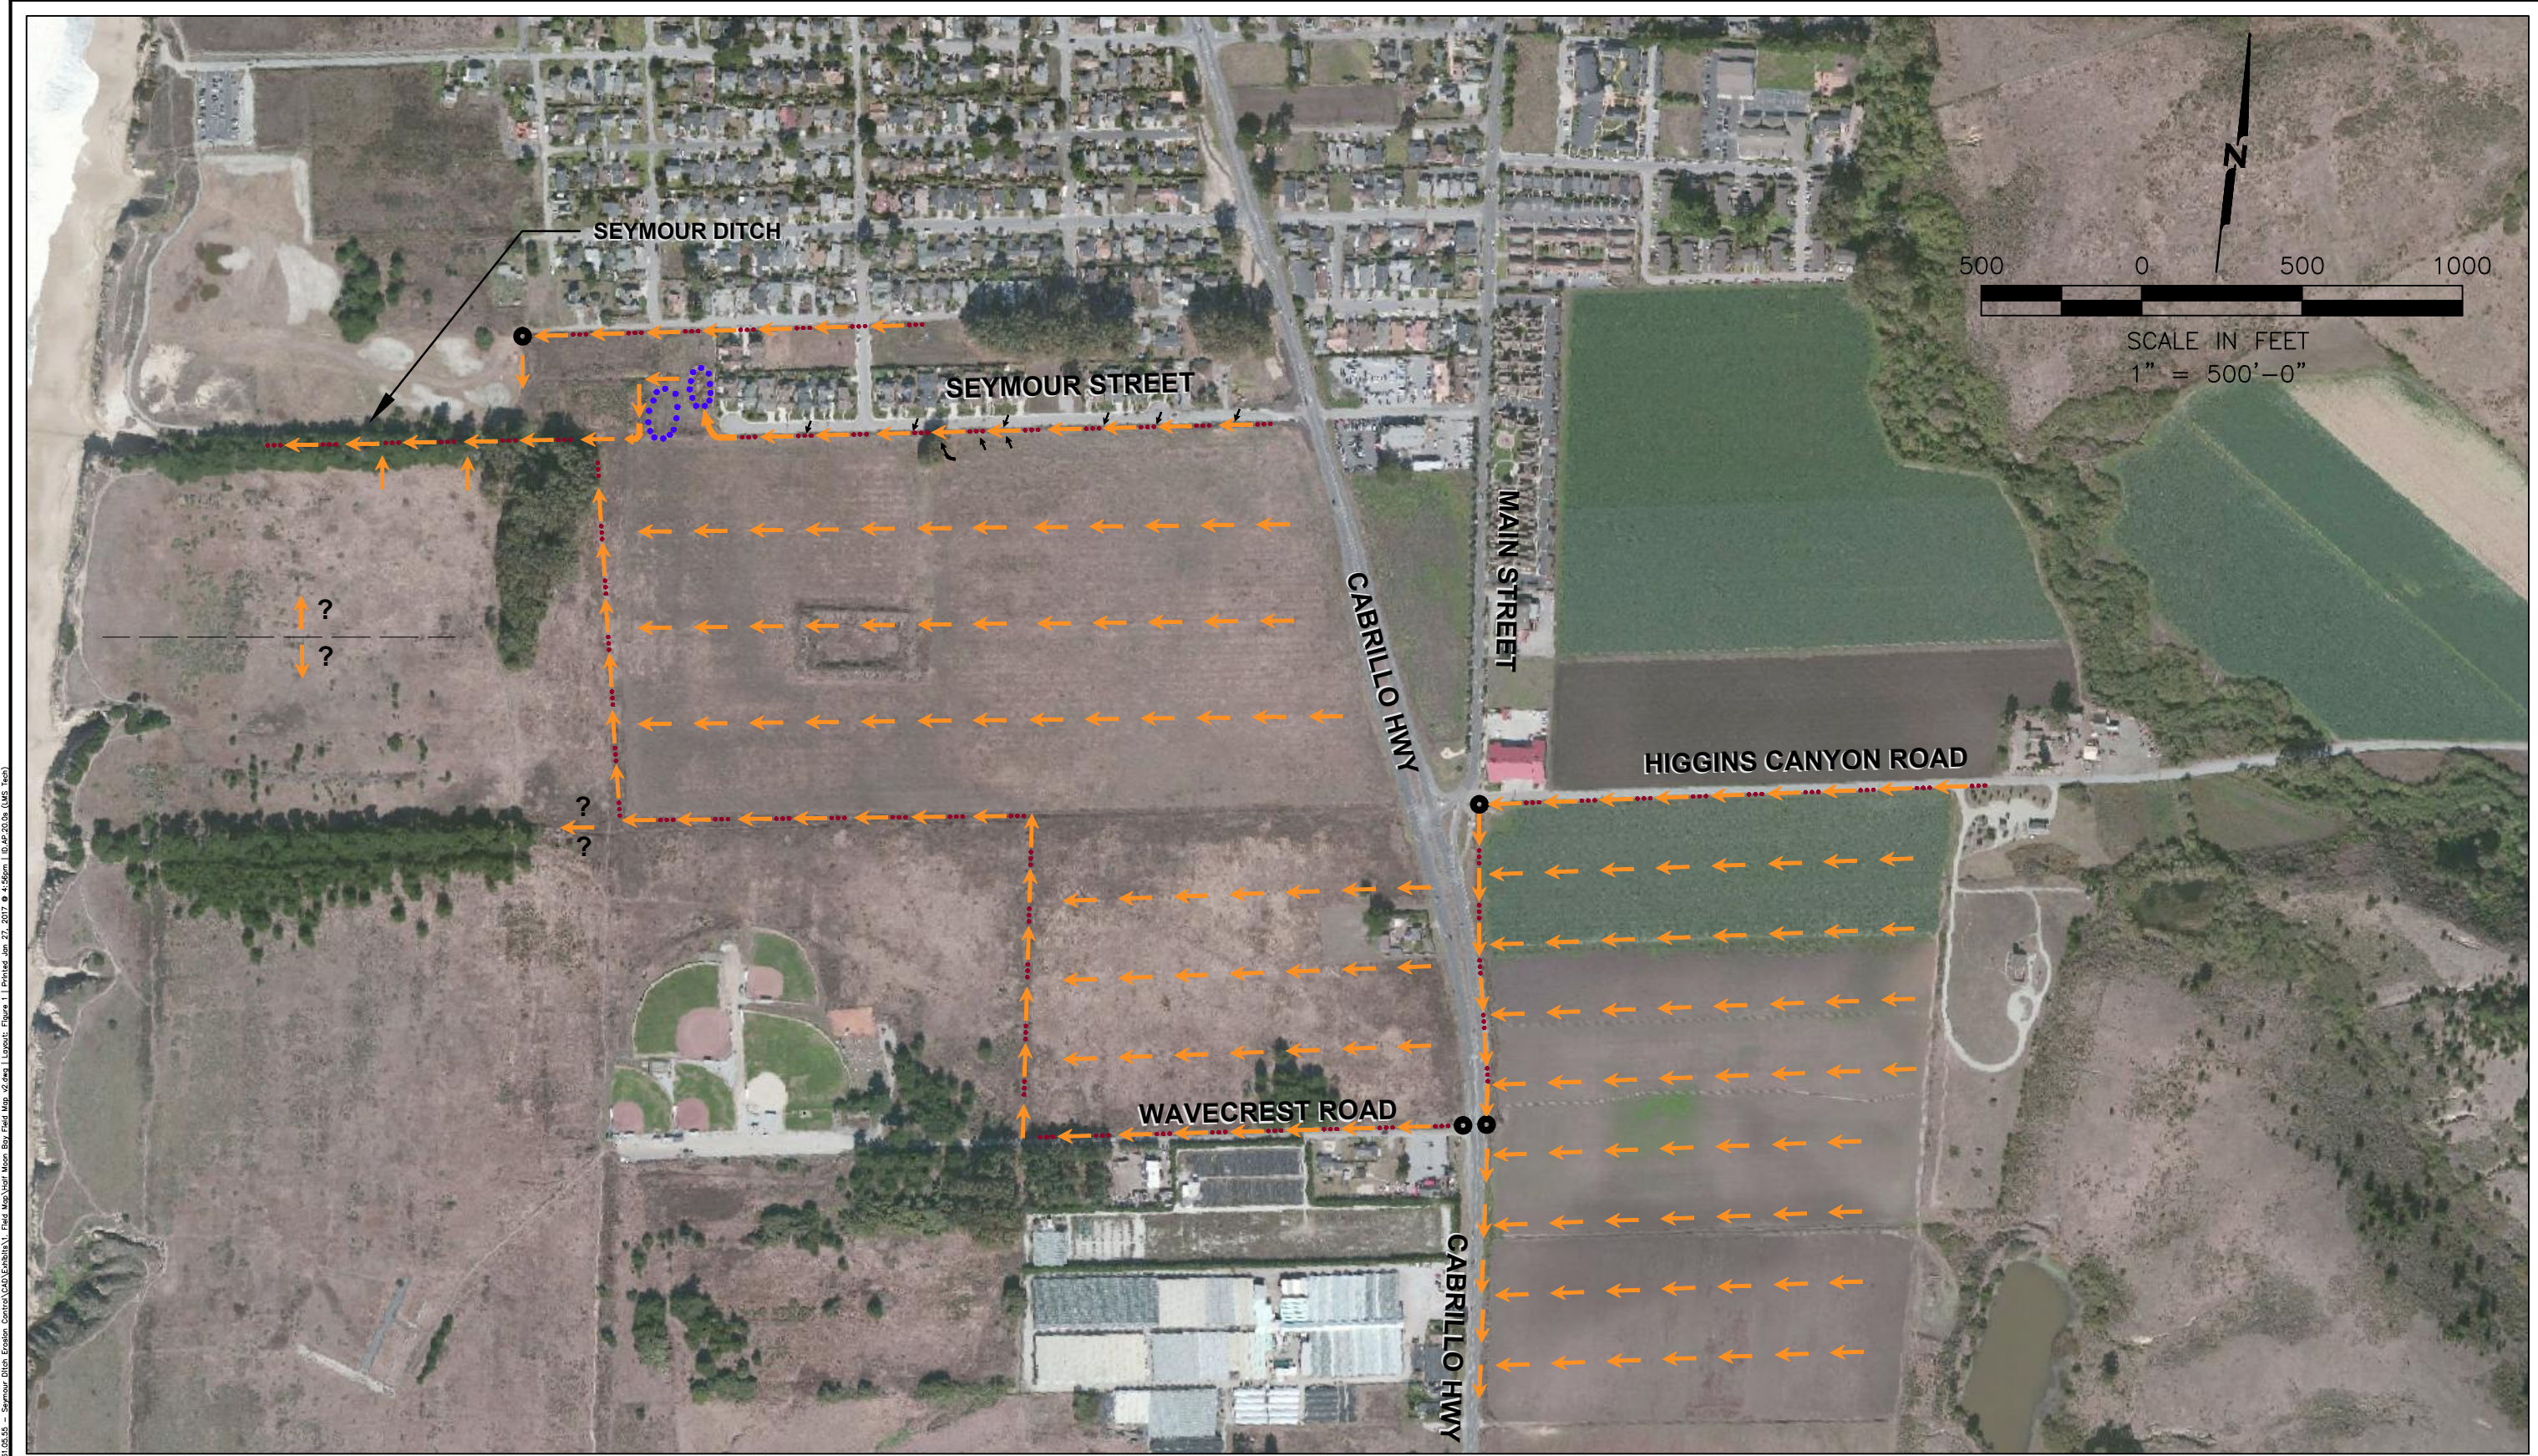
FIGURE
1

IT SHOULD BE NOTED THAT DURING OUR SITE VISIT ON JANUARY 22, 2017, FIELD AREAS IN THE VICINITY OF SEYMOUR DITCH WERE SATURATED WITH SURFACE STORMWATER.
